Publication No. 1C0948
August 1996

FILM ARTIFACT DIAGNOSTICS GUIDE for *Kodak X-Omat* Automatic Film Processors

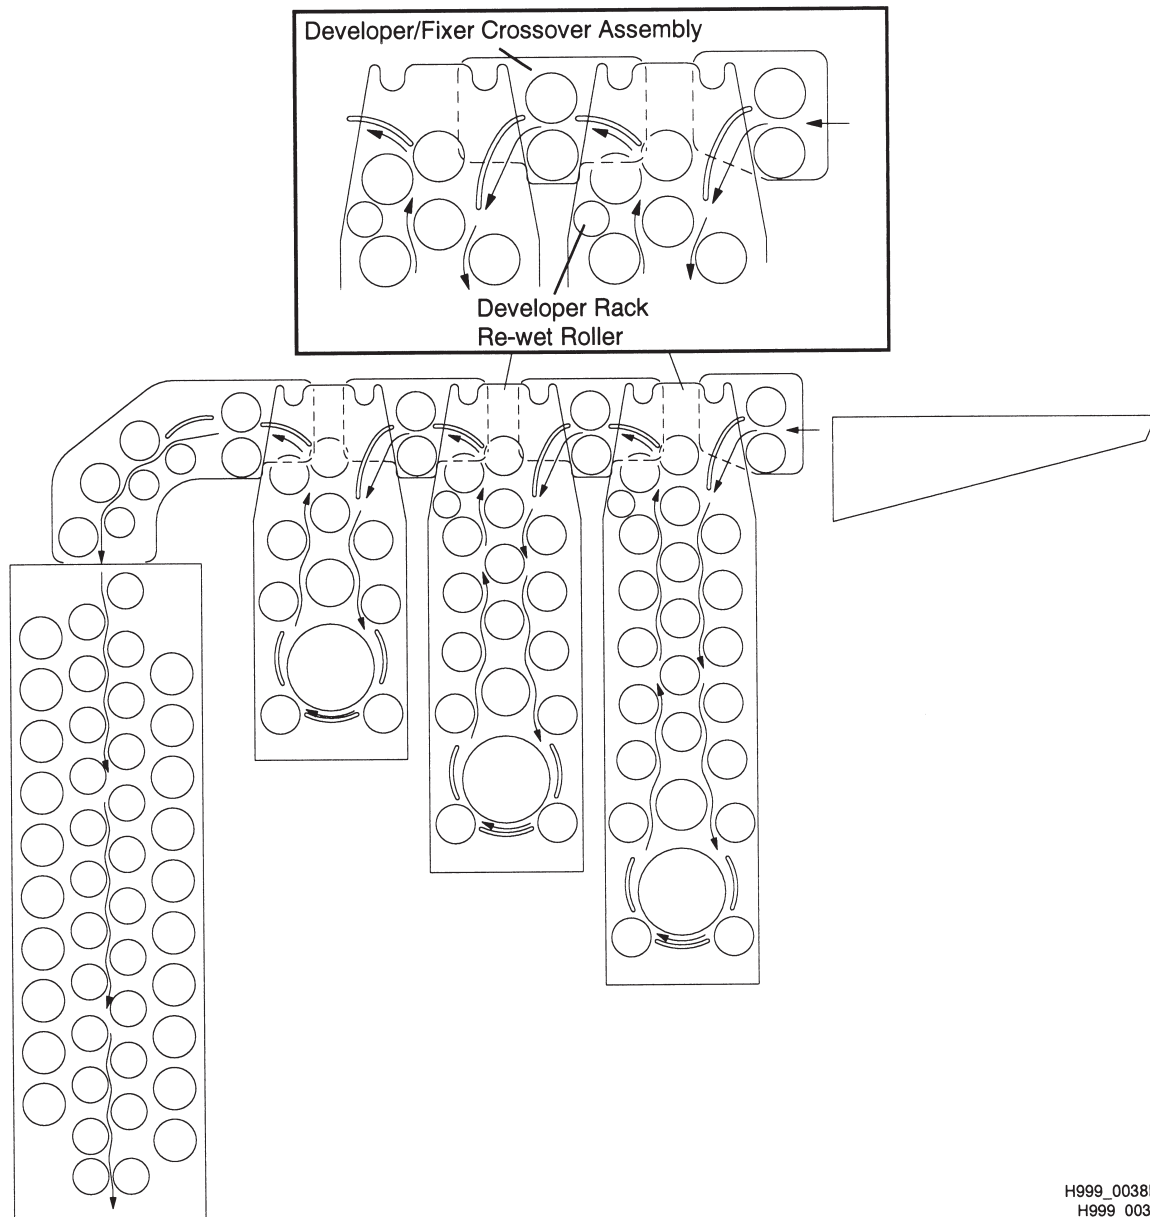
- chemical buildup on the Developer/Fixer Crossover Rollers or the Squeegee Rollers of the Developer Rack
- low level of developer solution in the Developer Tank
- improper ventilation and darkroom air pressure
- improper leveling of the processor
- Evaporation Covers not installed

- Clean any dirty Rollers. If necessary, replace damaged Rollers.
- If the processor has been in Standby Mode for over 30 minutes, feed a sheet of cleanup film into the processor before you process the patient's film.

- Check that the Springs in the Racks are adjusted to the proper tension.
 - The Rewet Roller in the Rack must remain in contact with the Roller that is above the solution level. The Rewet Roller transfers solution to the Roller above the solution level in order to prevent chemical buildup.
- Check that the Developer Tank is full of solution.
- Check that the processor is vented correctly using the manufacturer's specifications.
- Check that the processor is level.
- Check that the Evaporation Covers are installed.

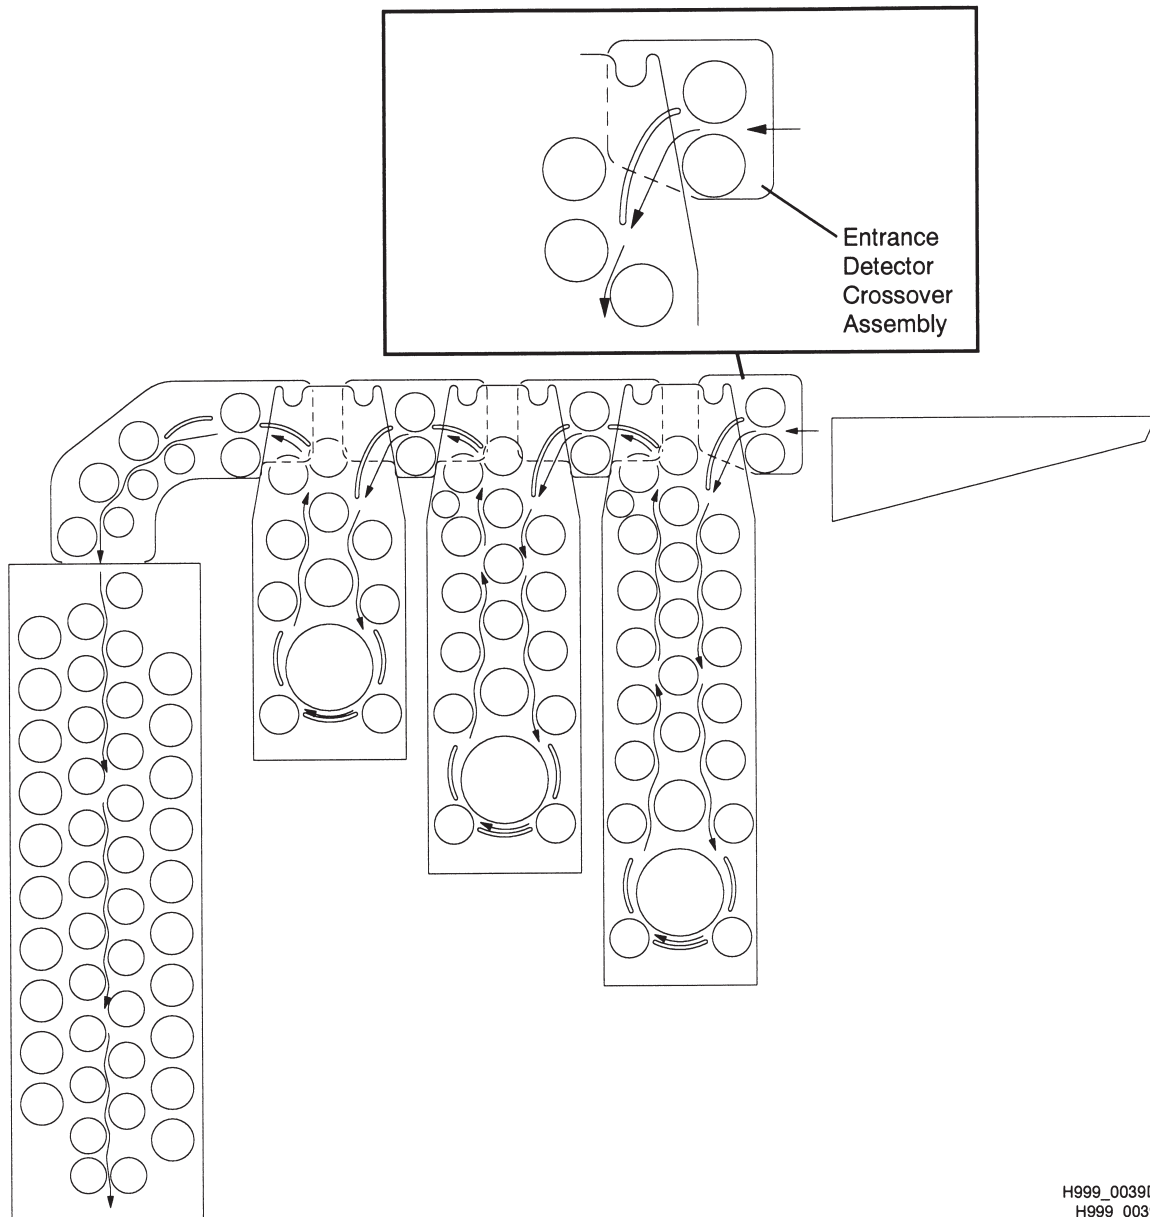
- excess pressure from the Entrance Rollers
- moisture on the Entrance Rollers
- light exposing the film before the trailing edge of the film exits the Entrance Roller

- Check that the Entrance Roller Assembly is positioned correctly in the processor.
- Check the Entrance Roller Assembly for:
 - squareness
 - warped or defective Rollers
 - worn Bearings
- Clean the Entrance Rollers with a damp cloth and dry them thoroughly before you process any patient films.
- Check that the processor is vented correctly using the manufacturer's specifications.

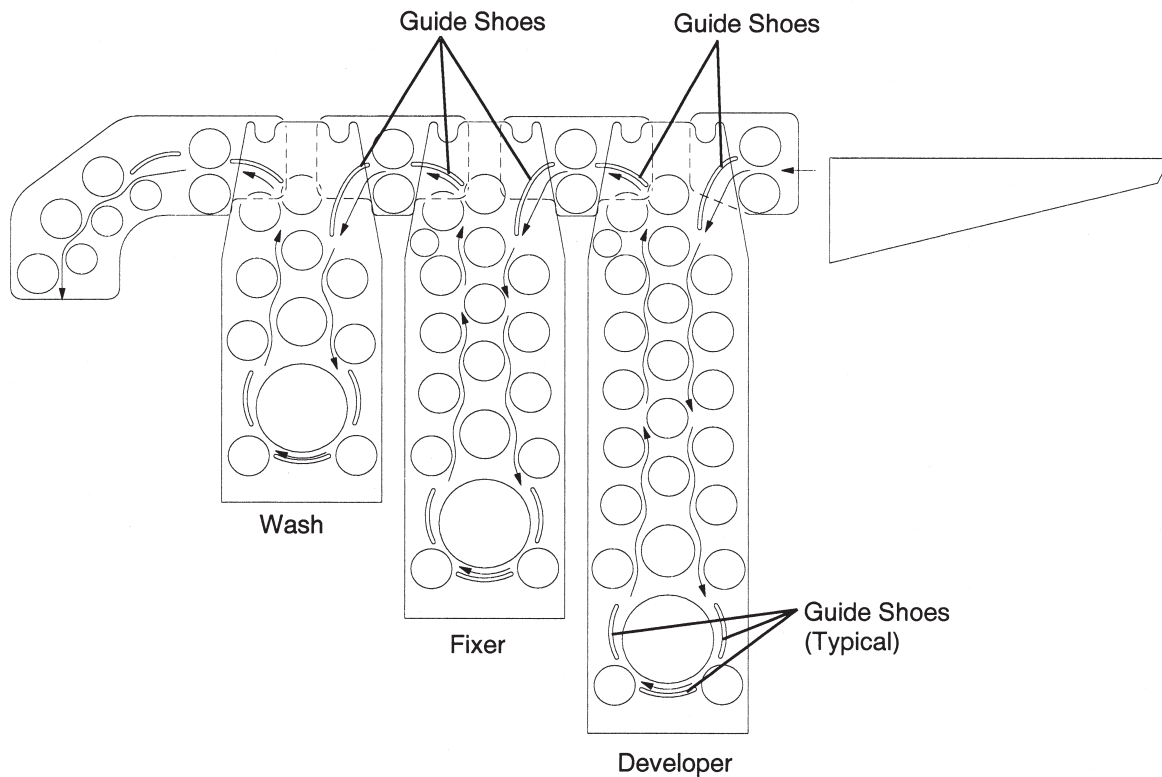
- If the Guide Shoe Marks appear on the top surface of the film, the marks are most likely caused by one of the Crossover Assemblies.
- If the Guide Shoe Marks appear on the bottom surface of the film, the marks are most likely caused by one of the Turnaround Assemblies or by the Guide Shoes in the Dryer Rack.

- Additional causes of Guide Shoe Marks include:
 - chemical deposits on the Guide Shoes (i.e., dried fixer solution)
 - corrosion of the Guide Shoes
 - worn Bearings or Roller components that misguide the film against the Guide Shoes

- Check that all Rollers are straight and rotating correctly.
- Check all the Racks for squareness.
- Inspect all Guide Shoes, and replace any bent Guide Shoes.
- Check the Roller Bearings for wear. If necessary, install new Bearings.
- Inspect all Rollers for dirt or a buildup of dried chemicals. Clean the Rollers according to the manufacturer's recommendations. Do not use abrasive materials to clean the Rollers or Guide Shoes.

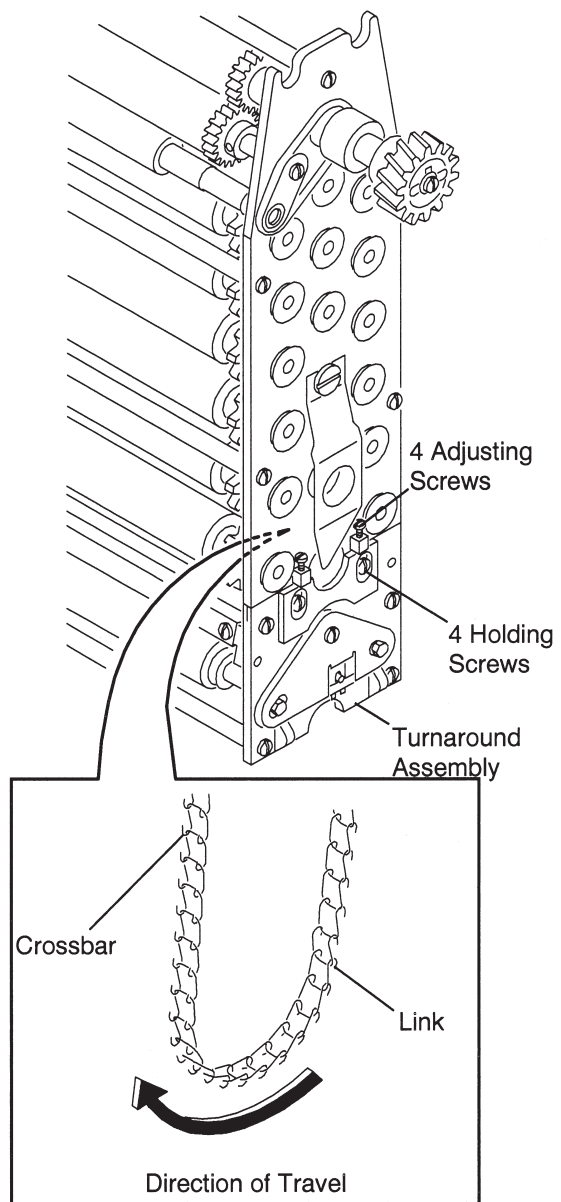
Chatter Lines can be caused by Drive Chains or Gears that do not drive smoothly.

- Gears on the Exit Rollers of the Developer Rack that are not properly aligned, are worn, or are damaged
- the drive mechanism on the Developer/Fixer Crossover Assembly that is too loose or too tight
- worn or broken Gear Teeth
- loose Setscrew or Pins
- wrong size Gear
- Drive Shaft out of alignment with the Worm Gears
- chemical buildup on the Gears
- Gears out of adjustment
- worn or corroded Worm Gears or Sideplate

- Adjust the drive system on the Developer Rack or Developer/Fixer Crossover Assembly according to the manufacturer's recommendations.
- Check for worn or damaged Sprockets that could prevent correct meshing with the Chain.
- Check for the correct tension of the Rack Chain.
- Check whether the Chain on the Drive Motor is worn or corroded. If necessary, install a new Chain.
- Install a new Ladder Chain.
- Do the Periodic Maintenance procedures as outlined in the Service Manual.

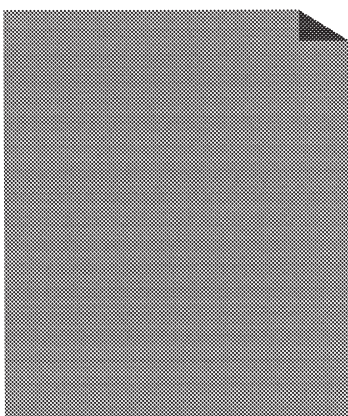
Bent Corners:

Bent Corners are easy to recognize because once a leading corner of the film is bent, you can hear the film flutter or stub on the Rollers as it is transported through the Racks.

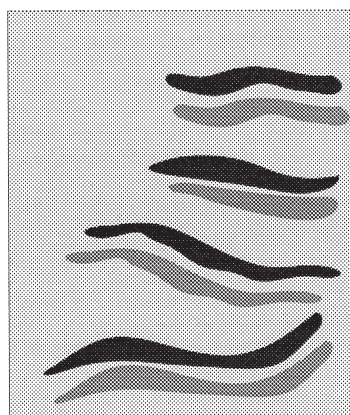
Flame Patterns:

Drying Streaks and Dryer Pattern artifacts can resemble Flame Pattern artifacts. For more details on Drying Streaks and Dryer Pattern artifacts, see page 51.

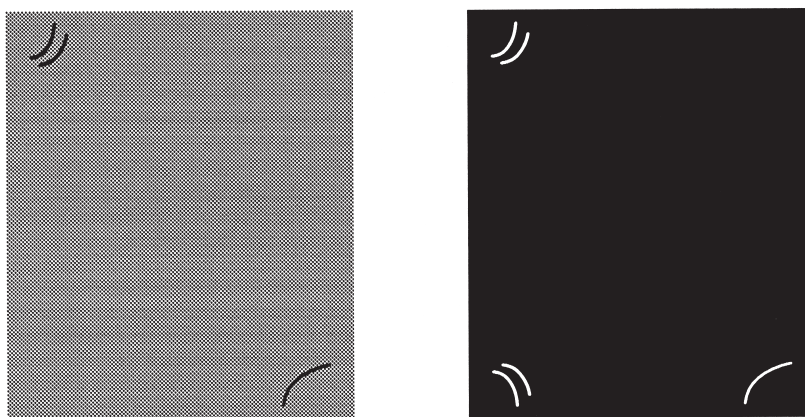
Kink Marks:

Kink Marks that appear on *T-Mat* films only appear as plus-density artifacts regardless of when the poor film handling occurred.

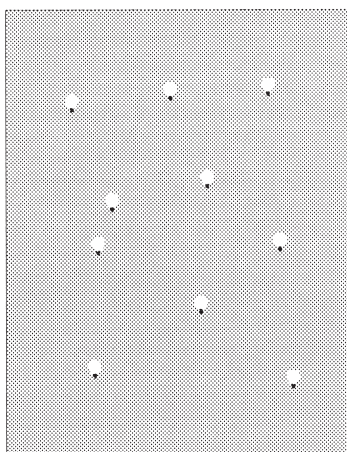
Pick-off Marks:

Pick-Off Marks are most visible in transmitted light. Unlike shadow images, Pick-Off Marks can be seen in reflected light.

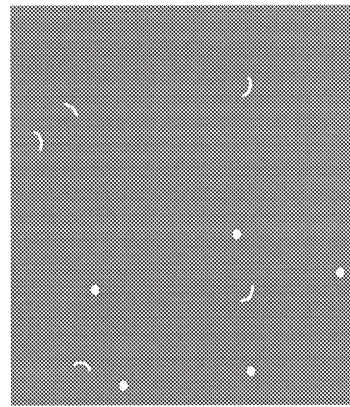
Shadow Images:

Shadow Images are visible only in transmitted light.

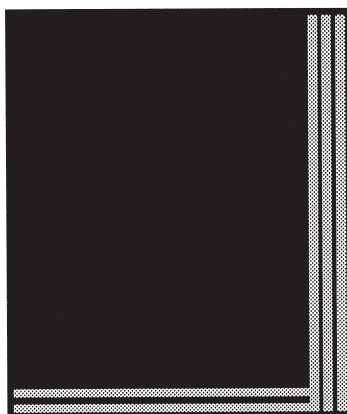
Shoreline:

Shoreline Patterns appear as a series of waves on the edges of a film, or as a variation in the gloss of the film surface. Shoreline Patterns only appear on the emulsion side of the film. Generally, this artifact is only visible in reflected light; however, if the artifact is severe, the pattern will be visible in transmitted light as a density variation on the edges of the film.

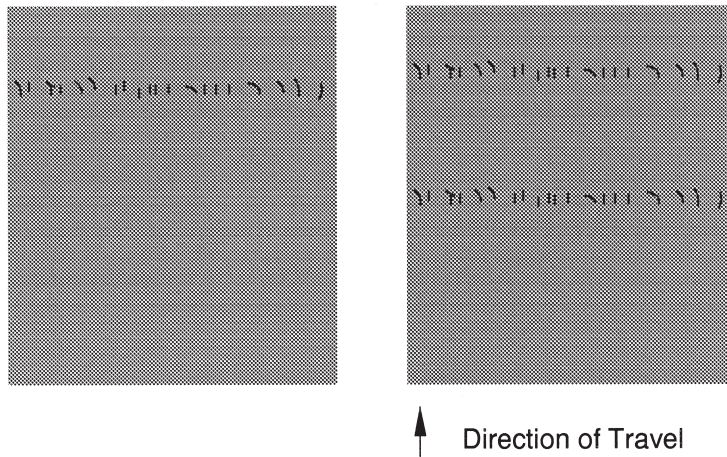
Skivings:

Skiving Marks are visible in transmitted light and may also be seen in reflected light. Often you will be able to feel the Skiving Marks on the surface of the film and be able to remove them from the film by using a knife.

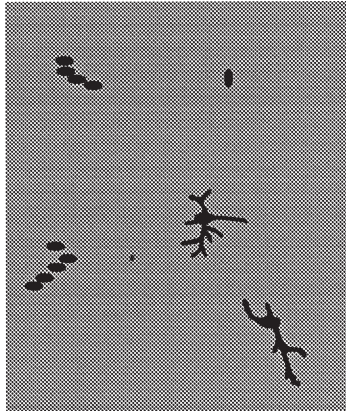
Static:

Static Marks are most visible in transmitted light, but in severe cases are also visible in reflected light.

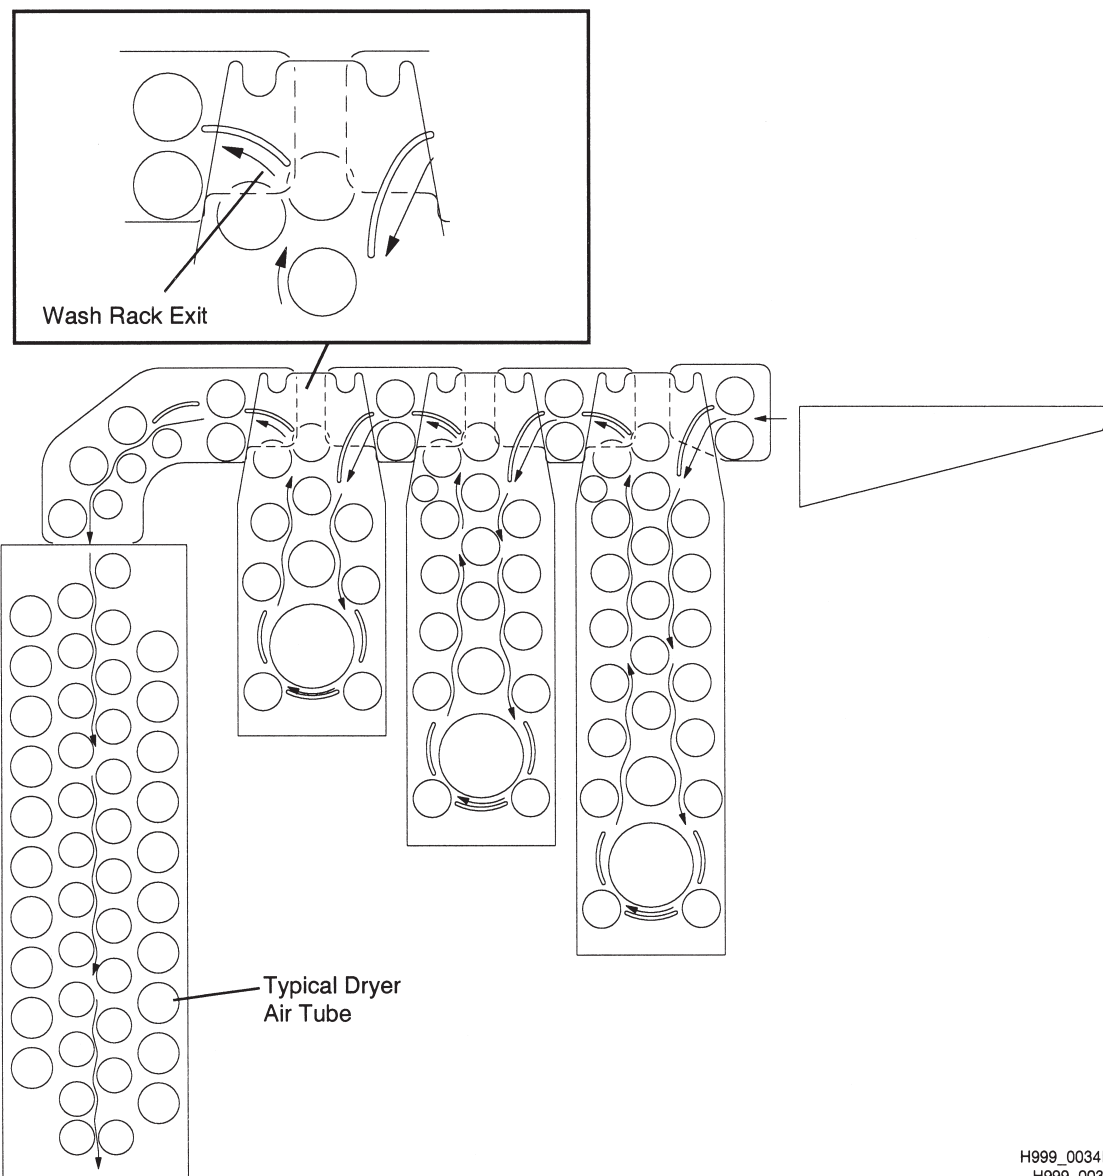
- obstructed airflow path
- obstructed Air Tube
- Air Tubes installed in the wrong orientation
- missing Baffle or Seal (Dryer Plenum)
- no water in Wash Tank or improper recirculation of wash water

- worn Squeegee or Dryer Roller Bearings
- insufficient squeegee action
- too much airflow
- poor drive in Dryer
- intermittent Interlock Switch
- processing film in incorrect chemical solution
e.g., use of RP film with RA chemicals
- exhausted chemistry
- level of wash water that is too low
- Dryer Belt that is too loose
- incorrect type of film or chemicals used for the processor model

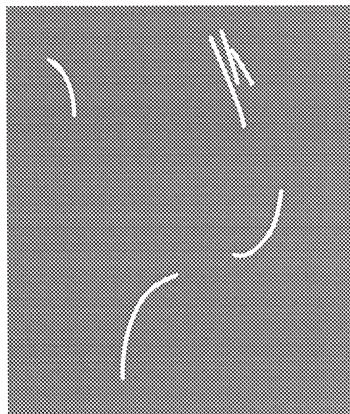
Surface Scratches:

Surface Scratches can appear as either plus-density or minus-density (dark or light) marks.

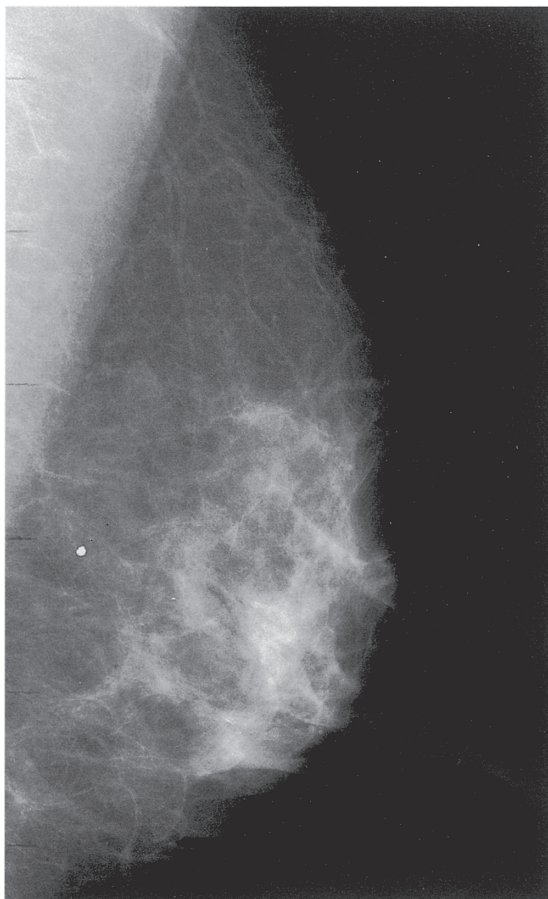
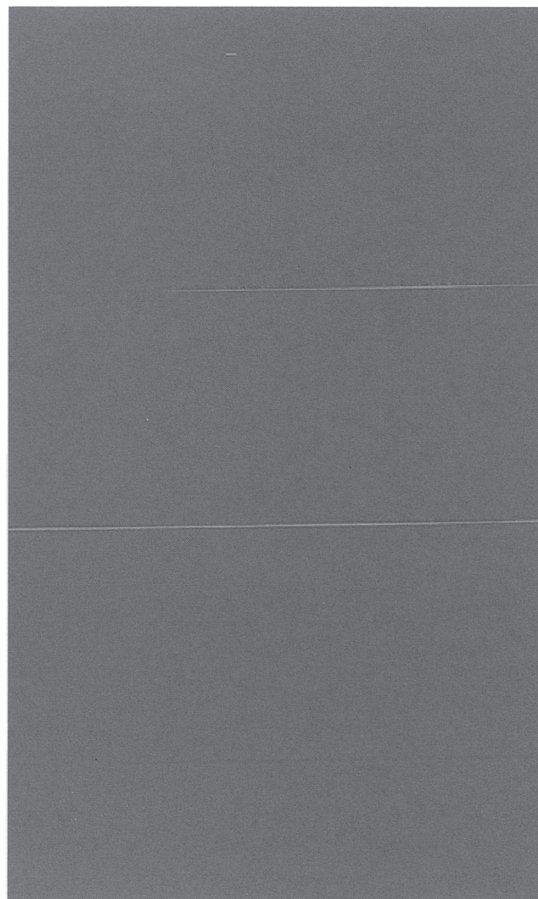
Guide Shoe Marks caused by ribbed Guide Shoes appear at 25.4 mm (1 inch) or a multiple of 25.4 mm (1-inch) intervals.

Marks caused by textured Guide Shoes appear at 0.06 mm (1/16 inch) or a multiple of 0.06 mm (1/16-inch) intervals.

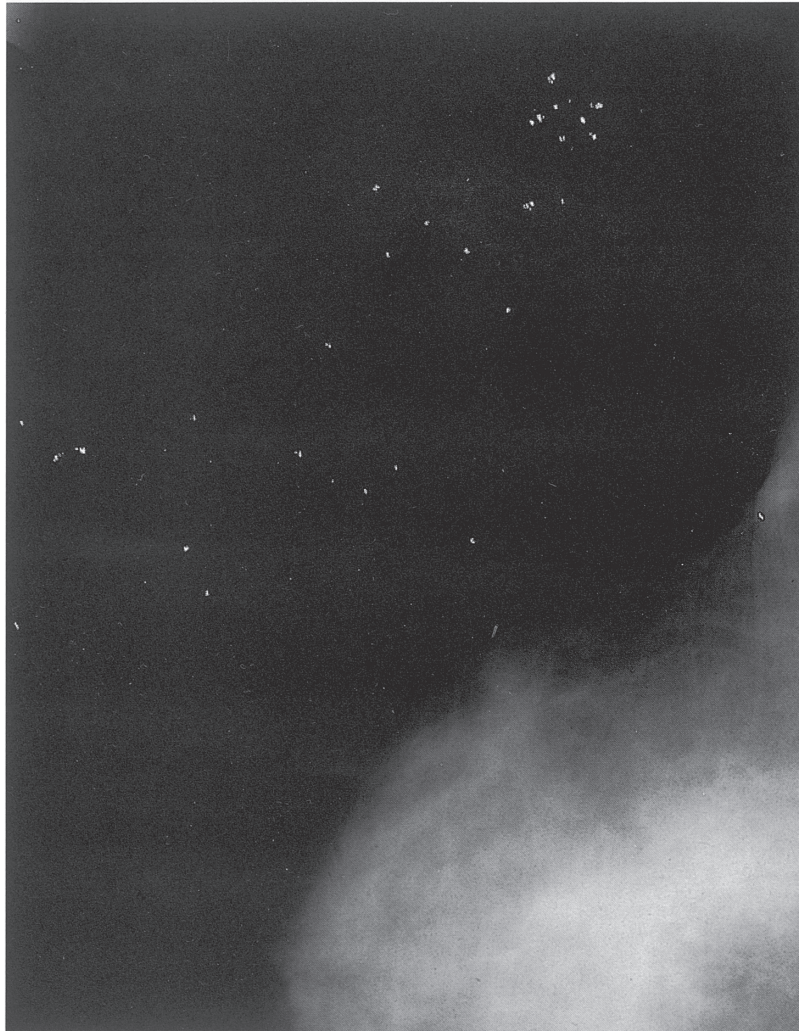
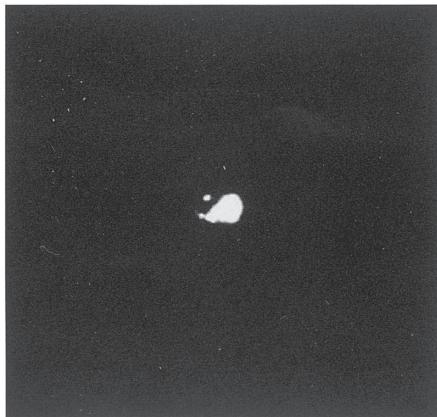
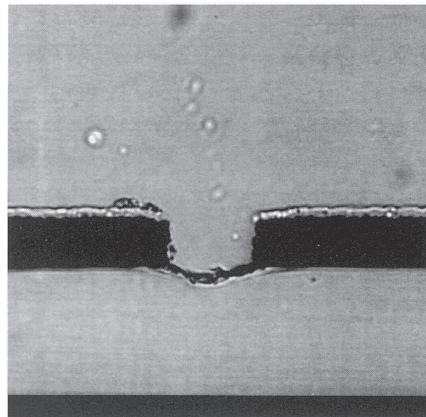
Pick-Off Marks

Magnification: 155X surface view

Magnification: 850X swollen

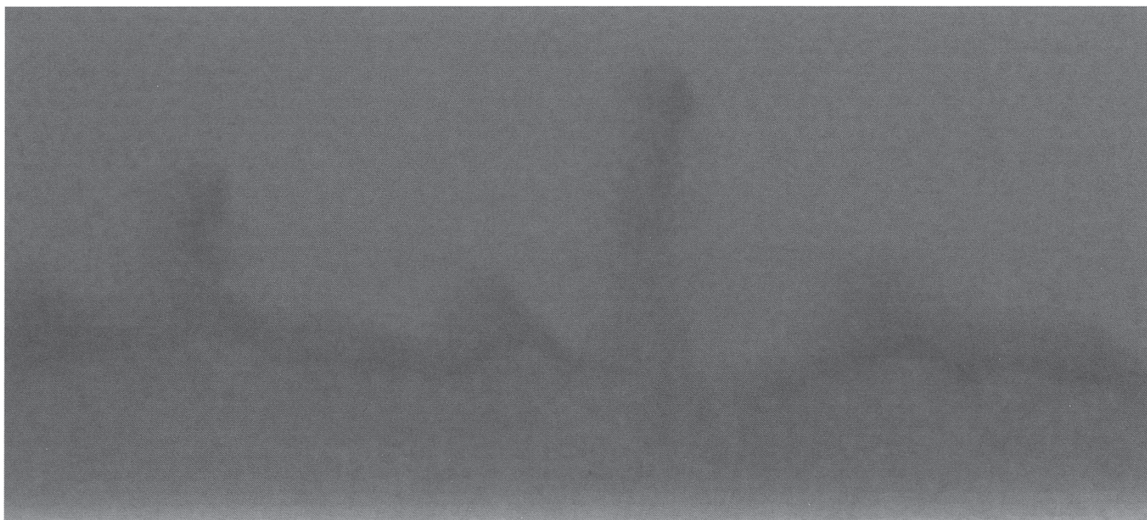
Runback Marks

Trailing Edge (Magnified View)

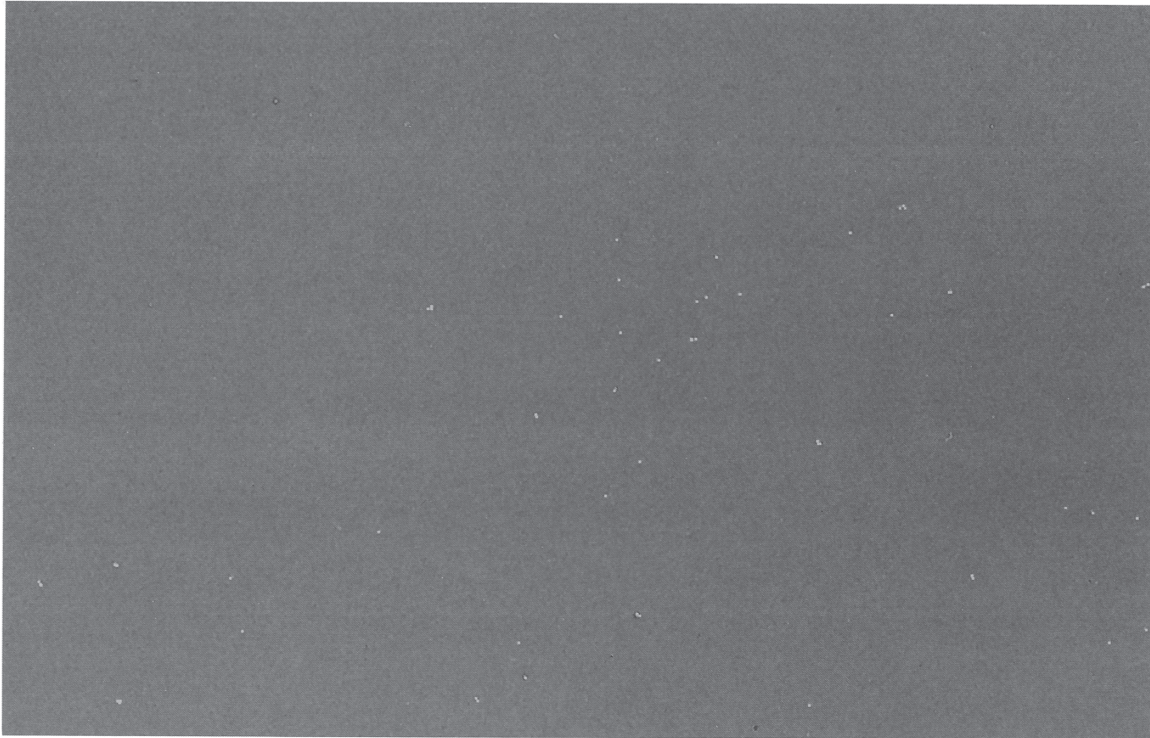
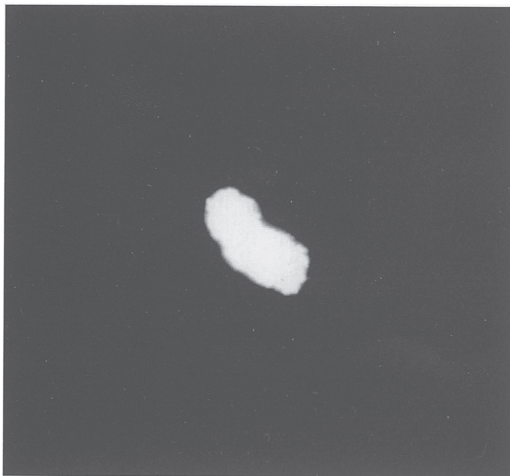
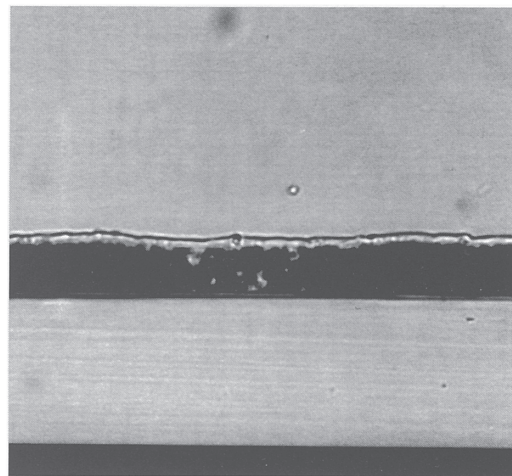
Shadow Images

Magnification: 155X surface view

Magnification: 850X swollen

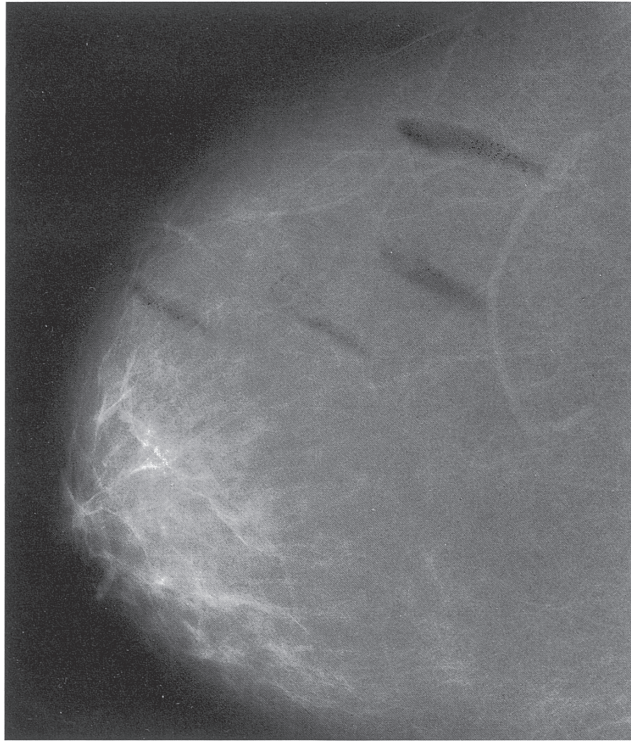
Spot Static

Artifacts caused by static appear as random, plus-density (dark) splotches which resemble a lightning bolt, tree branch, or a cluster of dots and dashes.

- electrostatic discharge on the surface of the film caused by dry air or static from:
 - certain clothing
 - carpeting
 - Feed Tray
 - low relative humidity

- Apply anti-static cleaner on the Feed Tray, Screens, and Cassettes.
- Install an anti-static mat.
- Ensure that the relative humidity in the darkroom remains between 30 and 50%
 - If necessary, use a humidifier to increase room humidity.
- Ground the Feed Tray.

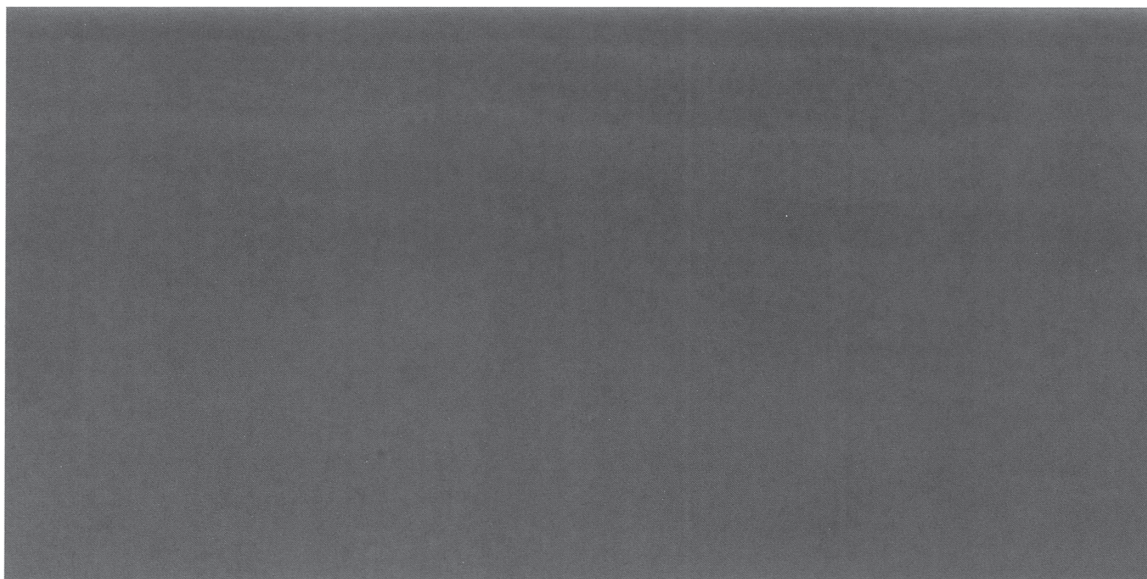
Surface Drying Streaks and Dryer Patterns

- Dryer Patterns are caused by an uneven removal of water from the film. This may be due to non-uniform airflow in the Dryer section. The patterns may also be from drying the film too fast. However, if the film is not dry as it exits the Dryer section, the film may be damp enough to pick up patterns from the exit Rollers, the Dryer Bin, or other films.

- inadequate venting of the processor
- excessive airflow
- wash water that is too cold or too hot
- uneven removal of water from film
- Dryer Roller installed in wrong orientation

- Use only RP developer and RP fixer, but either RA or RP film when operating the processor in the Standard or Rapid Cycle.
- Replace any worn Bearings.
